Manhole Inspection Summary

Manhole # S06EE2008MH

Location Address: **3609 SEVEN MILE LN**

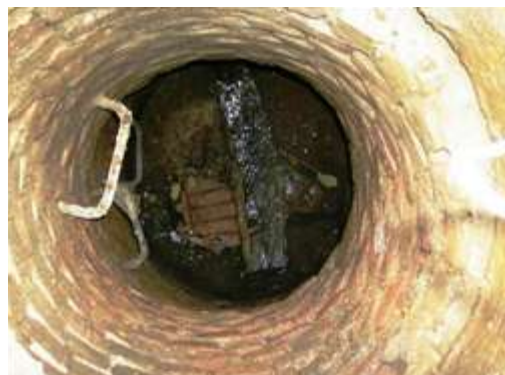
Top View

Frame leaks. Frame offset. Adjustment deterioration and infiltration. Corroded steps. Evidence of surcharge - Bench

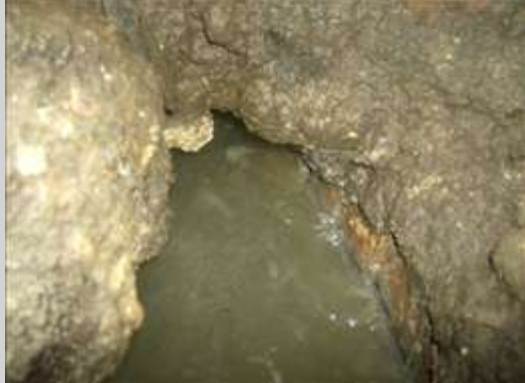
8 in. Circular Gravity Sewer Pipe Out @ 12 O'Clock

Invert Depth: **8.31** (ft.) Flow Characteristics: **Slow**

Deposits: ☒ None ☐ Mud ☐ Sludge ☐ Debris ☐ Grease

Infiltration: **None** Pipe Seal Cond: **Unknown**

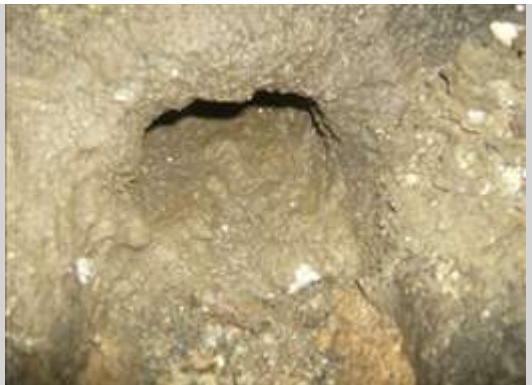
6 in. Circular Gravity Sewer Pipe In @ 3 O'Clock

Invert Depth: **7.79** (ft.) Flow Characteristics: **None**

Deposits: ☐ None ☒ Mud ☐ Sludge ☒ Debris ☐ Grease

Silt Depth: **4** (in.) Deposits Extent: **Heavy**

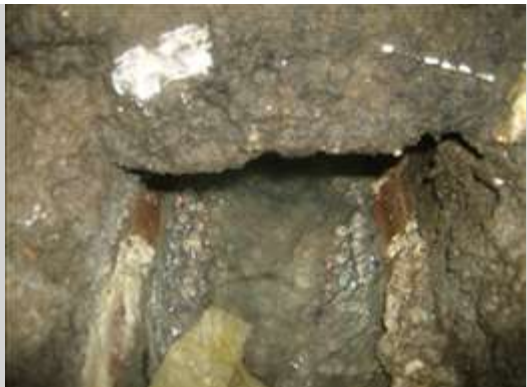
8 in. Circular Gravity Sewer
Pipe In @ 6 O'Clock

Invert Depth: **8.00** (ft.) Flow Characteristics: **Slow**

Deposits: ☐ None ☐ Mud ☐ Sludge ☐ Debris ☒ **Grease**

Silt Depth: **0** (in.) Deposits Extent: **Light**
